XC2200 Derivatives

16/32-Bit Single-Chip Microcontroller
with 32-Bit Performance
XC2000 Family / Alpha Line

Errata Sheet

V1.11 2014-10

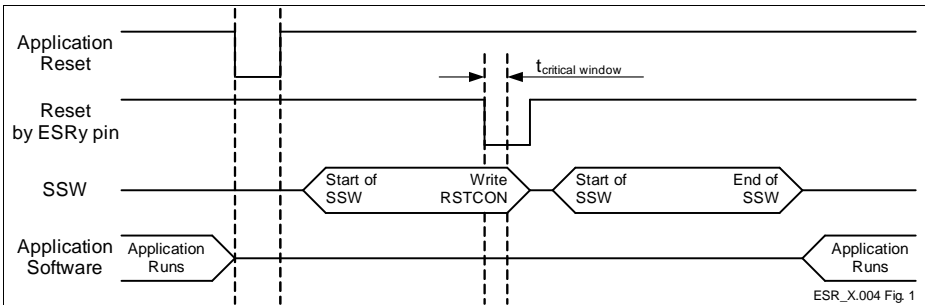
Figure 1 Critical application reset sequence

ESR X.004 Wrong Value of SCU_RSTCONx Registers after ESRy Application Reset

SCU_RSTCONx registers are reset only by Power-On, but they may be wrongly affected after a second application reset requested by an ESRy pin. This may lead to the SCU_RSTCONx register values being set to zero, which could unexpectedly disable reset sources within the user application. The conditions which lead to this behavior are:

1. First, an application reset by SW (software), CPU (Central Processing Unit), MP (Memory), WDT (Watchdog Timer) or ESRy (External Service Request y) occurs.
2. Following this, an application reset on an ESRy pin occurs.
3. If the above mentioned ESRy reset occurs during a critical time window of the SSW (startup software), then it's possible that the application will operate with the wrong SCU_RSTCONx register value. The critical time window occurs when the SSW is writing the SCU_RSTCONx registers, and at the same time, the ESRy reset request is processed by the reset circuitry. The width of this critical window $f_{critical\ window}$ is less than 13 cycles.

- Initialize `SCU_RSTCONx` registers by user software after any reset, or
- assure that a second application reset request with an ESR pin does not occur during the critical time window.

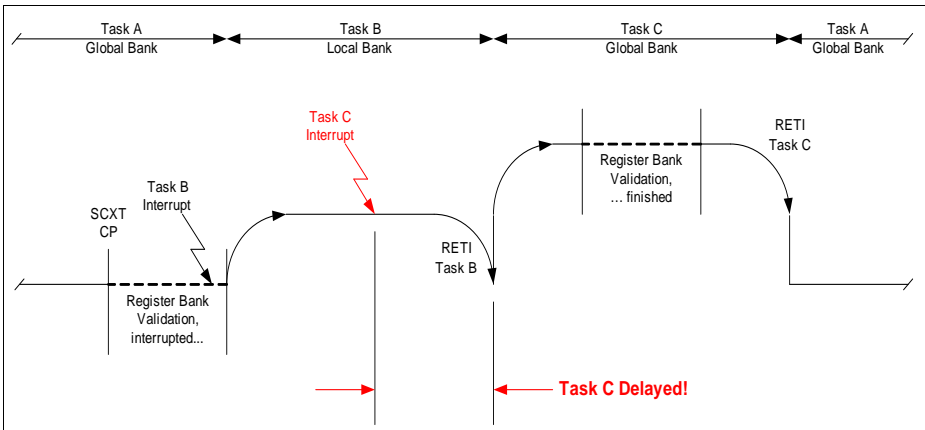
Figure 2 Example for Case 2: Interrupt Service for Task C delayed

- The Context Pointer CP is written to (e.g. by POP, MOV, SCXT ... instructions) within a routine (Task A) that uses a **global** register bank (bit field PSW.BANK = 00_B), i.e. the context for this routine will be modified,
- This context switch procedure (19 cycles) is interrupted by an interrupt request (Task B) which is programmed (with GPRSELx = 1X_B) to automatically use one of the **local** banks via the bank selection registers BNKSEL0...3 (i.e. the interrupting routine has a priority level ≥ 12),
- Before the corresponding interrupt service routine is finished, another interrupt request (Task C) occurs which is programmed (with GPRSELx = 00_B) to automatically use the **global** bank via the bank selection registers BNKSEL0...3 (i.e. the interrupting routine has a priority level ≥ 13).

In this case service of this interrupt request (for Task C) is delayed until bit field PSW.BANK becomes 00_B after executing the RETI instruction at the end of the routine (Task B) using the local bank.

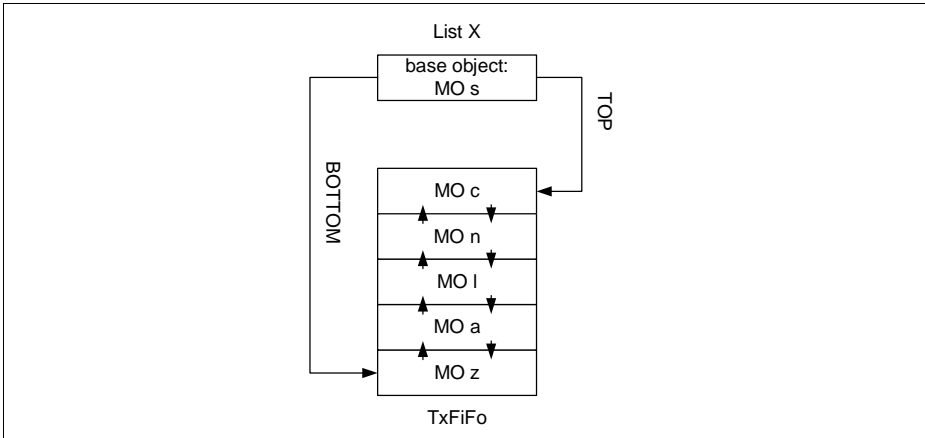
Figure 3 FIFO structure

After the successful transmission of a Tx FIFO element, a Tx overflow interrupt is generated if the FIFO base object fulfils these conditions:

If Tx FIFO overflow interrupt needed, take the FIFO base object out of the circular list of the Tx message objects. That is to say, just use the FIFO base object for FIFO control, but not to store a Tx message.

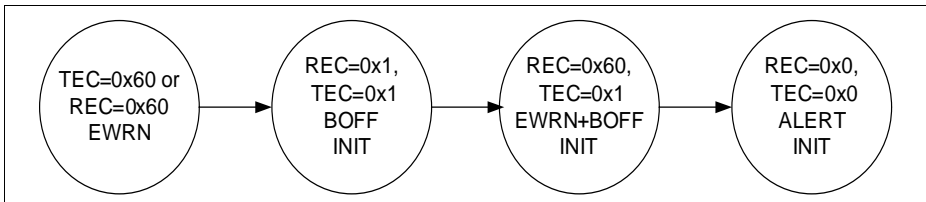
Figure 5 Alert Interrupt Behavior in case of Bus-Off

When the threshold for error warning (EWRN) is reached (default value of Error Warning Level EWRN = 0x60), then the EWRN interrupt is issued. The bus-off (BOFF) status is reached if TEC > 255 according to CAN specification, changing the MultiCAN module with REC and TEC to the same value 0x1, setting the INIT bit to 1_B, and issuing the BOFF interrupt. The bus-off recovery phase starts automatically. Every time an idle time is seen, REC is incremented. If REC = 0x60, a combined status EWRN+BOFF is reached. The corresponding interrupt can also be seen as a pre-warning interrupt, that the bus-off recovery phase will be finished soon. When the bus-off recovery phase has finished (128 times idle time have been seen on the bus), EWRN and BOFF are cleared, the ALERT interrupt bit is set and the INIT bit is still set.

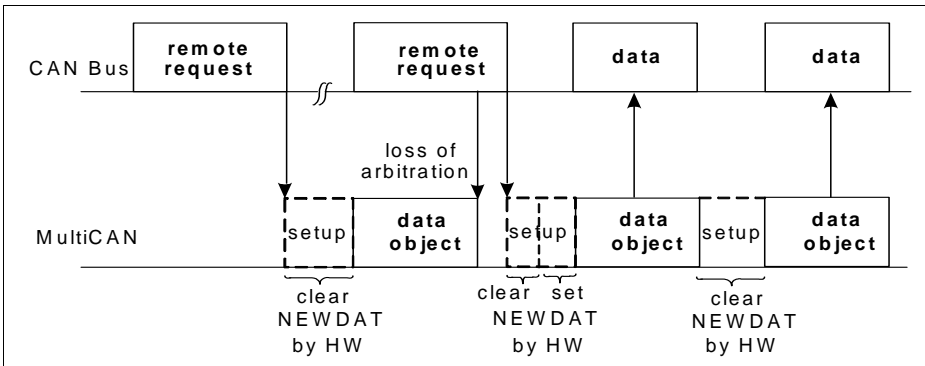
Figure 6 Loss of Arbitration

When the appropriate message object (data frame) triggered by the first remote frame wins the arbitration, it will be sent out and NEWDAT is not reset. This leads to an additional data frame, that will be sent by this message object (clearing NEWDAT).

There will, however, not be more data frames than there are corresponding remote requests.
