XC2200 Derivatives

16/32-Bit Single-Chip Microcontroller
with 32-Bit Performance
XC2000 Family / Alpha Line

Errata Sheet

V1.11 2014-10

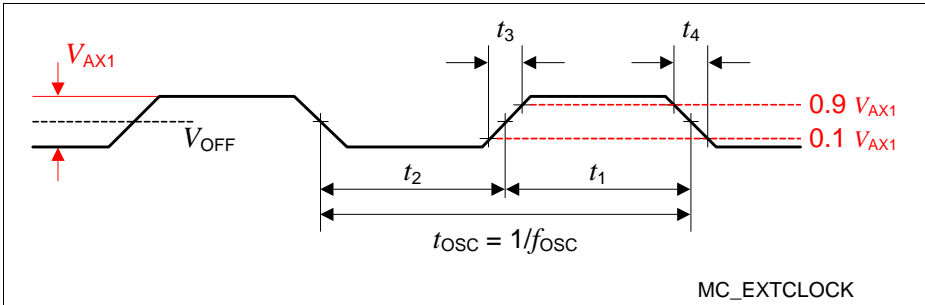
Figure 7 External Clock Drive XTAL1

Parameter	Symbol	Values			Unit	Note / Test Condition
		Min.	Typ.	Max.		
Oscillator frequency	f_{osc} SR	4	-	40	MHz	Input=Clock Signal
		4	-	16	MHz	Input=crystal or ceramic resonator
Input voltage amplitude on XTAL1 ¹⁾	V_{AX1} SR	$0.3 \times V_{DDIM}$	-	-	V	4 to 16 MHz
		$0.4 \times V_{DDIM}$	-	-	V	16 to 25 MHz
		$0.5 \times V_{DDIM}$	-	-	V	25 to 40MHz

1) The amplitude voltage V_{AX1} refers to the offset voltage V_{OFF} . This offset voltage must be stable during the operation and the resulting voltage peaks must remain within the limits defined by V_{IX1} .

Note: For crystal or ceramic resonator operation, it is strongly recommended to measure the oscillation allowance (negative resistance) in the final target system (layout) to determine the optimum parameters for oscillator operation. The manufacturers of crystals and ceramic resonators offer an oscillator evaluation service. This evaluation checks the crystal/resonator specification limits to ensure a reliable oscillator operation.
